Use Attainability Analysis

WBID 0470 Peddler Creek

Submitted by
SES Inc.

Missouri Department of Natural Resources
Water Protection Program

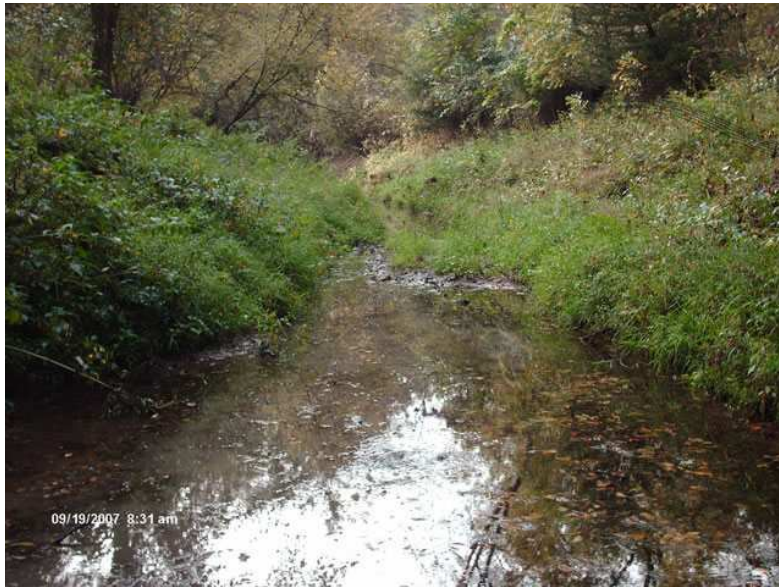
Site# 1 Photo ID# 45, Downstream

Banks vegetated: common grasses and forbs of the area; 70% algae in water

None

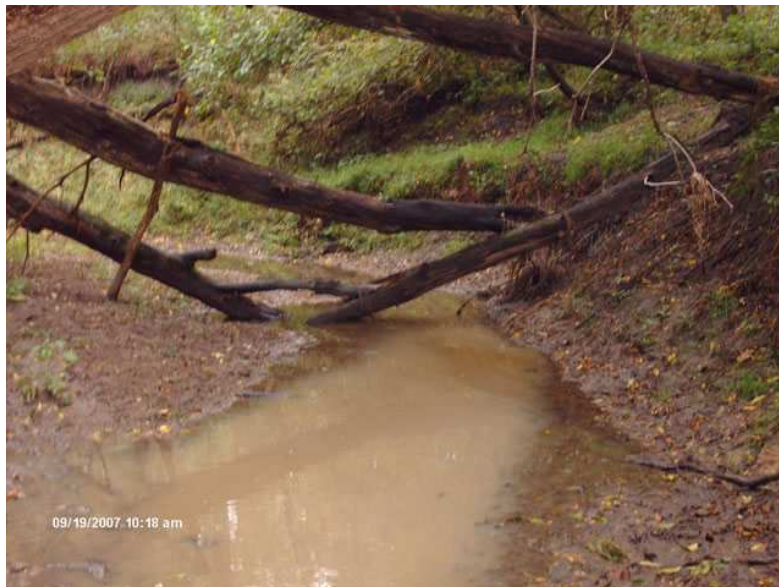
Site# 2 Photo ID# 49, Downstream

banks vegetated except for flood/high water erosion; 5 arrowhead waterplants; other common veg.; forest

narrow channel, lots of silt, looks recently flooded (this year). Only see animal trax, unstable banks, fallen trees

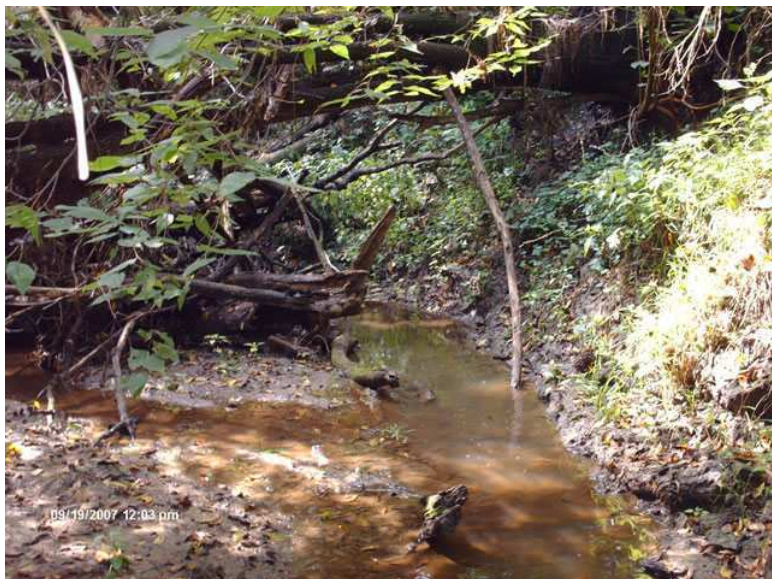
Site# 3 Photo ID# 51, Upstream

vegetated along banks to water's edge

very narrow channel, very "muddy", our feet sink in it almost a foot deep. Lots of vegetation on banks, fallen trees
